Bridget Bohac, Chief Clerk Office of the Chief Clerk Texas Commission On Environmental Quality. P.O. Box 13087, MC-105 Austin, Texas 78711-3087 13 September 2013

Re: Permit No. WQ0015065001

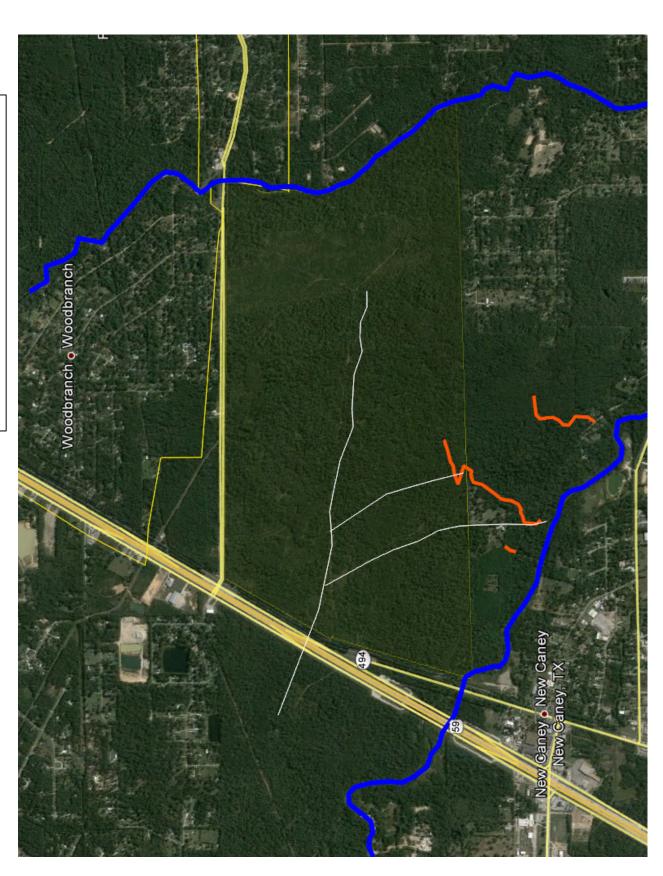
Please consider attachment 1) an overview of the proposed development site east of US Hwy 59. There are several relevant features on this image. First are the existing creeks, shown in blue. Second are the surface expressions of subterranean faults shown as white traces. These faults define local relative 'highs' and, with the exception of times of flood will be shown to control run off from the current TCEQ approved site. These local

relative 'highs' also limit drainage areas. So for instance, drainage passing under US59 from the west and south of the east west trending fault drains south to the corner of Comer Reinhart Rd. Surface drainage from North of the East West trending relative high and to the East of US 59 drains to the east and ultimately into Peach Creek. Some portion of the subsurface flow ultimately percolates to Caney Creek. To understand the soil percolation please refer to the Soil Survey of Montgomery County, TX. USDA publication. <a href="http://soildatamart.nrcs.usda.gov/Manuscripts/TX339/0/Montgomery.pdf">http://soildatamart.nrcs.usda.gov/Manuscripts/TX339/0/Montgomery.pdf</a> and <a href="http://soildatamart.nrcs.usda.gov/Manuscripts/TX339/0/Maps/Index.pdf">http://soildatamart.nrcs.usda.gov/Manuscripts/TX339/0/Maps/Index.pdf</a> sheets 68 and 78.

This image also includes orange features that are eroded clay benches that were contained in laminated fine sand deposits. The local dip of these benches, most probably resulting from the faulting, is to the Southeast..

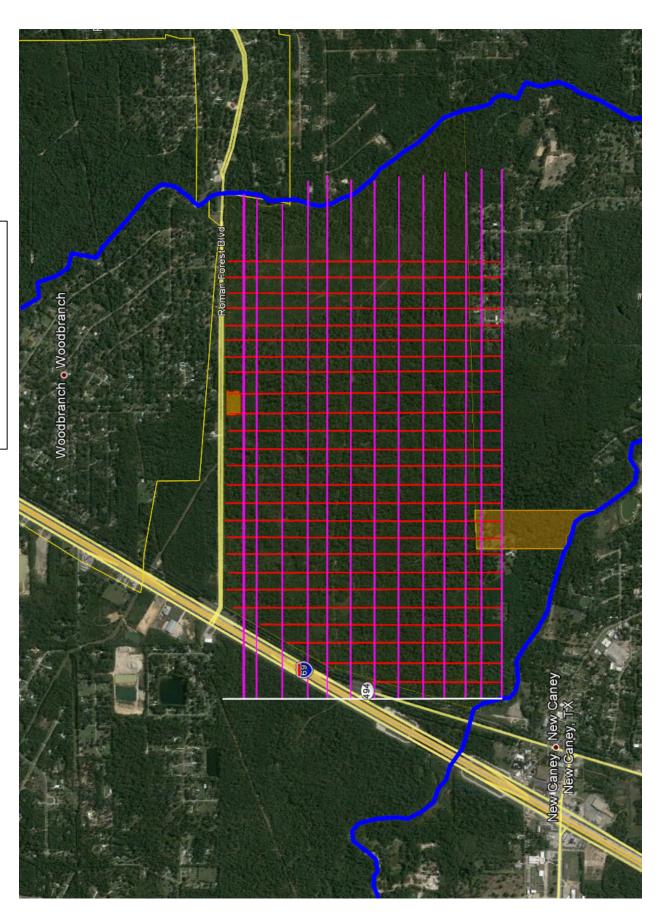
Attachment 2) represents an arbitrary cross sectional grid based on SRTM geospatial data. The horizontal sample accuracy of the base grid is +/- 45m and relative vertical accuracy projected to a given indicated line should be greater than 0.5m given that each degree of the great circle constitutes approximately 58 miles . This is sufficient to identify drainage paths. This attachment also shows the locations of the TCEQ permitted site and the F.J Foulks property.

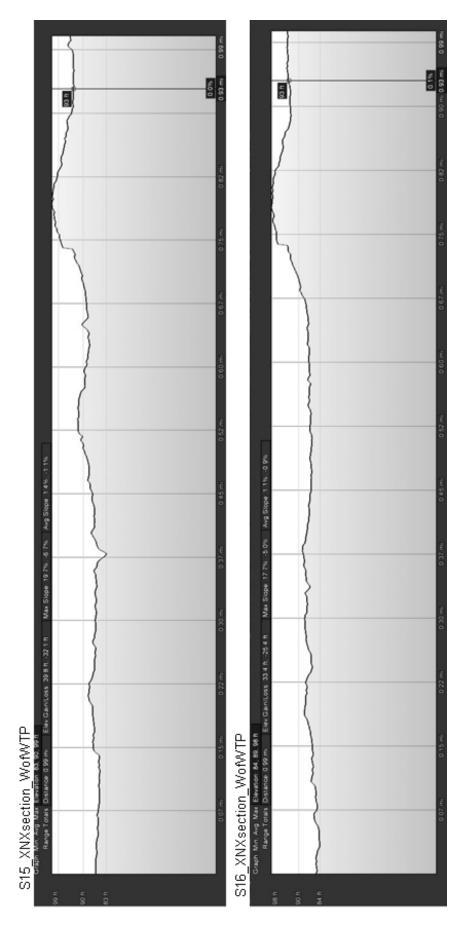
4a) West of Site

Attachment 4a) and 4b) show the South to North cross sections through the site and to both the east and west. Notice the increase in elevation to the west of the TCEQ approved site.

South to North Sections-West of Site

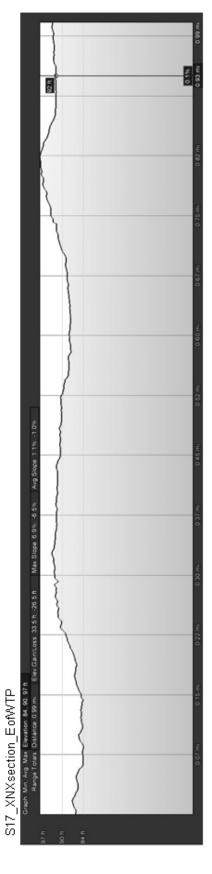
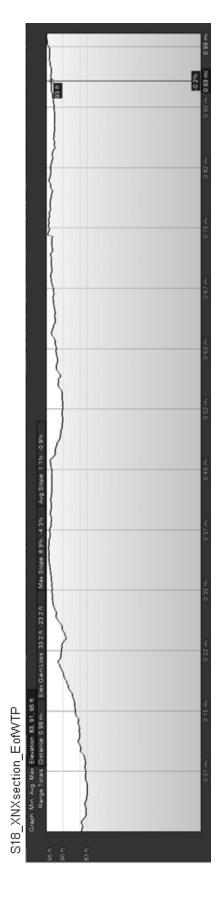
4b) East of Site

South to North Sections-East of Site

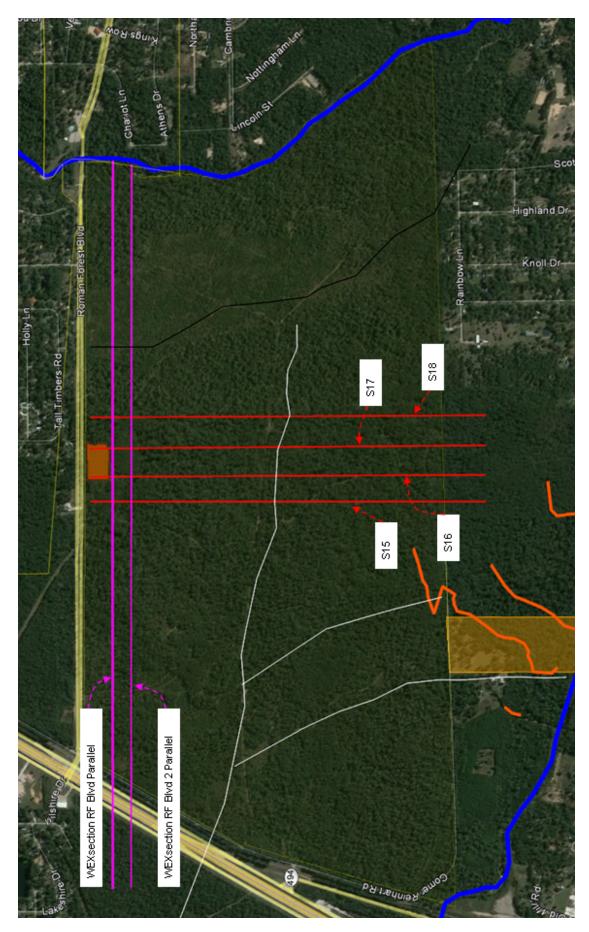
Attachment 5) illustrates the positions of the cross sections of Attachments 4a) & 4b). This image also illustrates the proximity of the TCEQ approved site to the estimated flood plane of Peach Creek.(the black line)

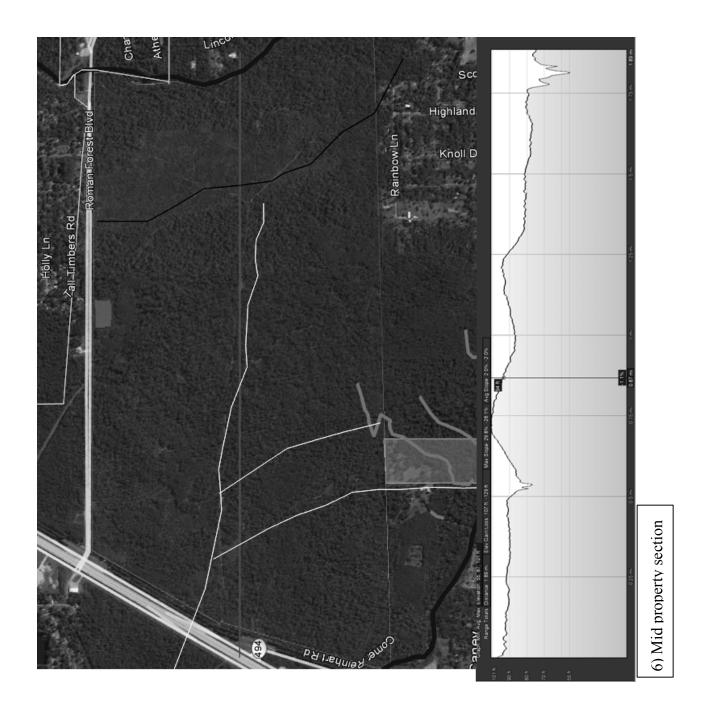
Attachment 6) is a mid property West to East cross-section illustrating the absence of "Pumpkin Gully" and the presence of other erosive features to the west of the drainage path proposed by Lennar Homes of Texas in their permit application.

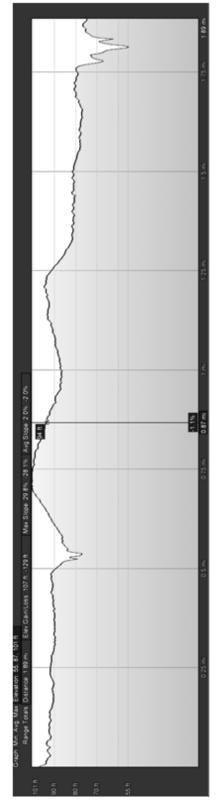
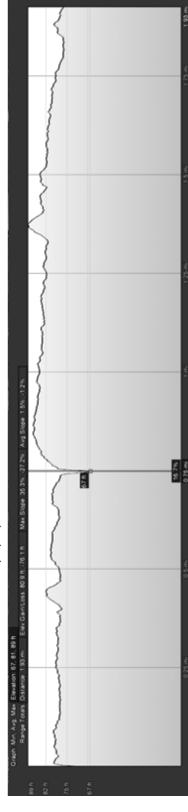
7) Mid property section

Attachment 7) compares a Lennar Homes of Texas south boundary cross section with the mid property cross section of Attachment 6) illustrating that there is no path using natural drainage courses to route any of the proposed alternatives into "Pumpkin Gully" from the TCEQ approved site.

Mid Point EW Crosssection from Attachment 6)

Crosssection at Lennar Homes of Texas South property line
